**Existing Potential Areas of Concern
Falcon DBPS
El Paso County, CO**

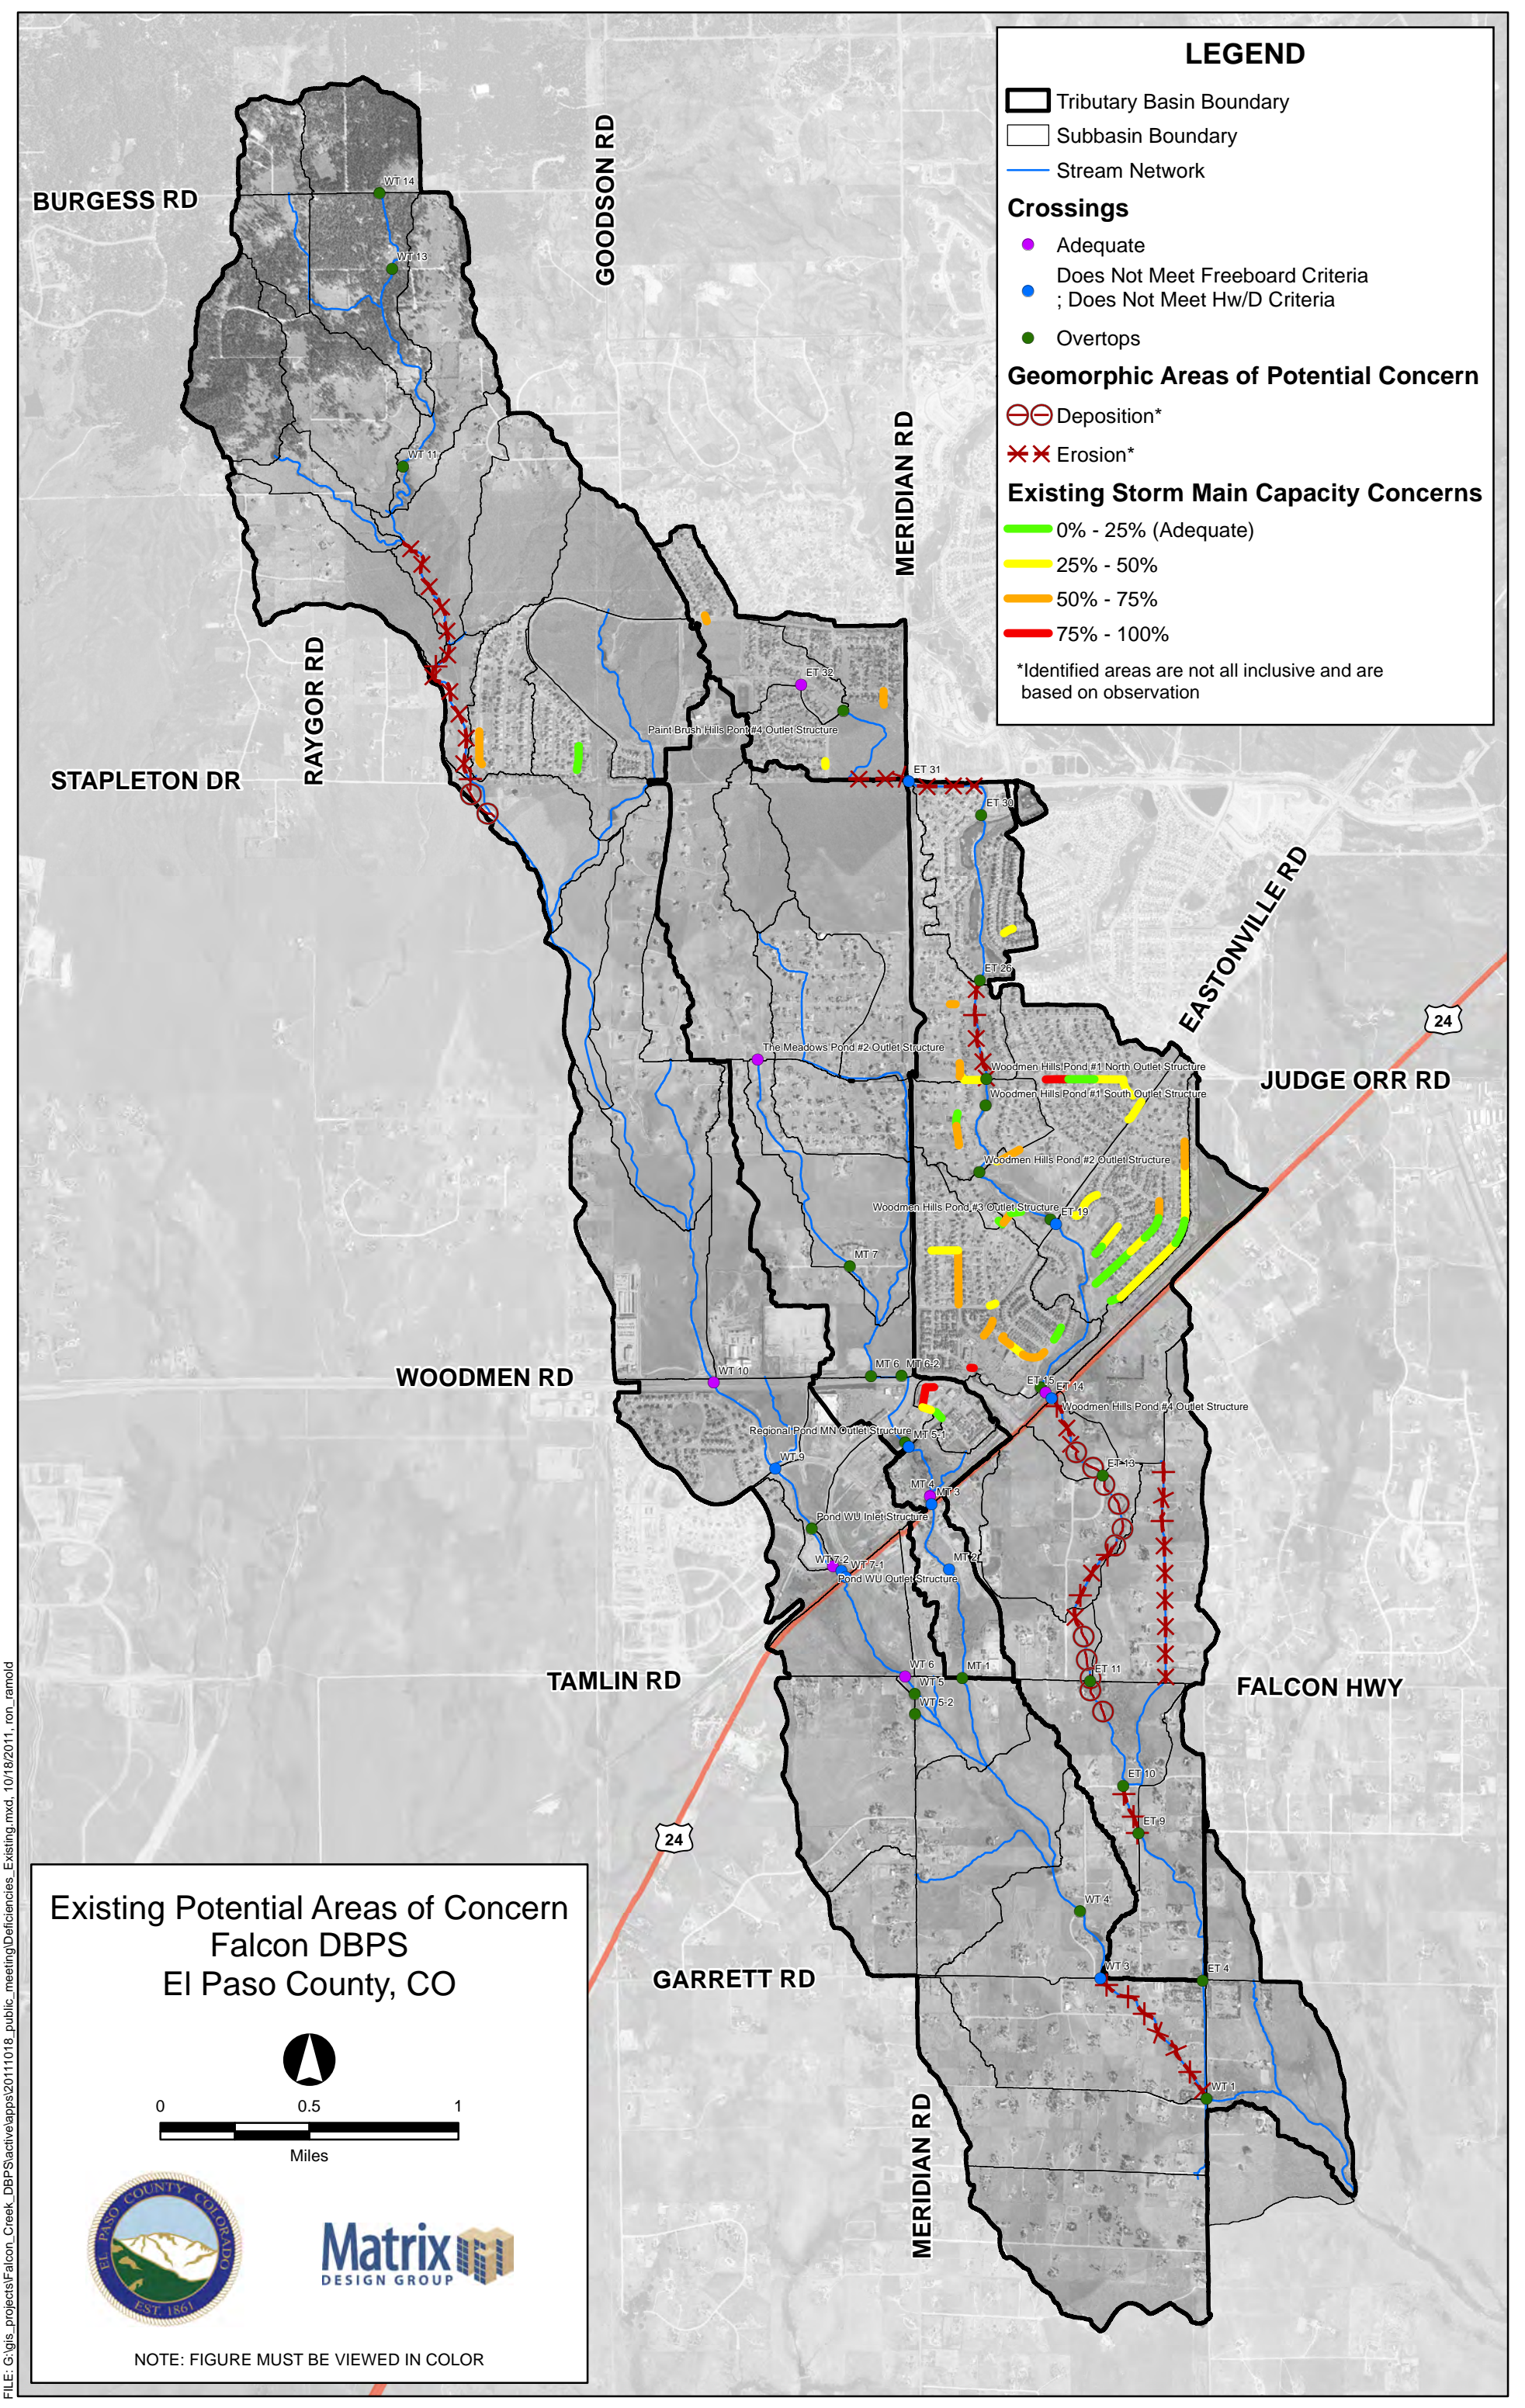
- Adequate
- Does Not Meet Freeboard Criteria ; Does Not Meet Hw/D Criteria
- Overtops

- ⊖ Deposition*
- ✕ Erosion*

- █ 0% - 25% (Adequate)
- █ 25% - 50%
- █ 50% - 75%
- █ 75% - 100%
